**TESTING FOR COMPATIBILITY OF
STEEL WITH BIODIESEL**

SwRI® Project No. 08.13070

**Ms. Lorri Grainawi
Steel Tank Institute
570 Oakwood Road
Lake Zurich, IL 60047**

April 7, 2008

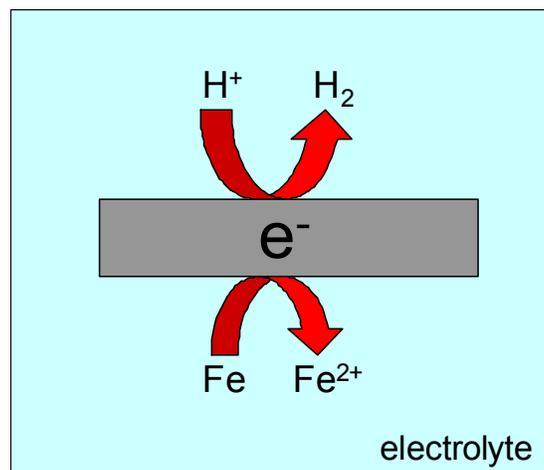
Figure 1. Schematic of corrosion process of steel under acidic conditions.

Long-term exposure of steel coupons to biodiesel and biodiesel/petroleum diesel fuel blends was carried out. Due to the high solution resistance and very low conductivity of the fuel blends, the corrosion rate is expected to be very low, if any. Corrosion occurs in the presence of charge carriers, for example, ions. At very low conductivity, no charge carriers are present, thus the corrosion does not occur. In the fuel blends, it was expected that as the fuel aged, acetic acid would form and hydrolyze to increase the number of charge carriers, thus increasing the corrosion rate. A schematic of the corrosion process of steel under acidic conditions is shown in Figure 1.

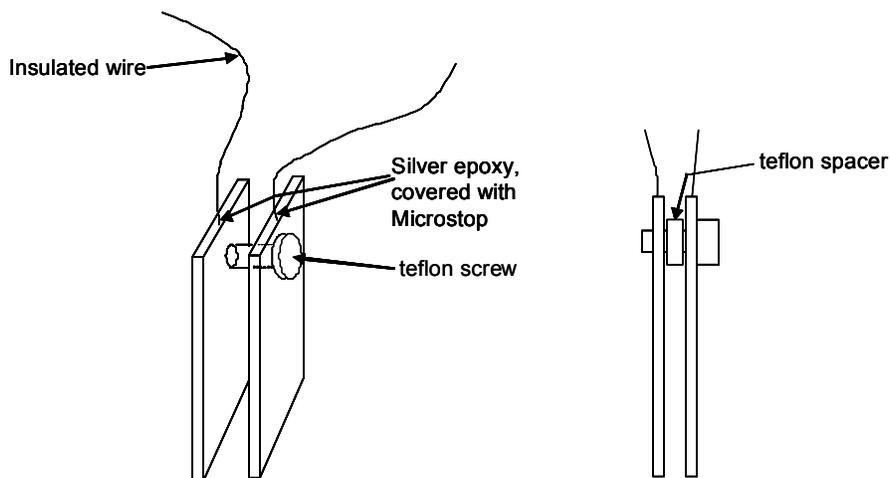
Figure 2. Schematic of experimental setup used in electrochemical impedance tests.

The electrochemical impedance spectroscopy (EIS) measurements were carried out in a two-electrode setup, in which two electrodes made out of carbon steel were placed in a Teflon cell with very small separation distance. One electrode acted as the reference electrode, while the other one acted as the working electrode. The impedance signal was measured across the two electrodes. No separate standard reference electrode was used. A schematic of the experimental setup is shown in Figure 2.

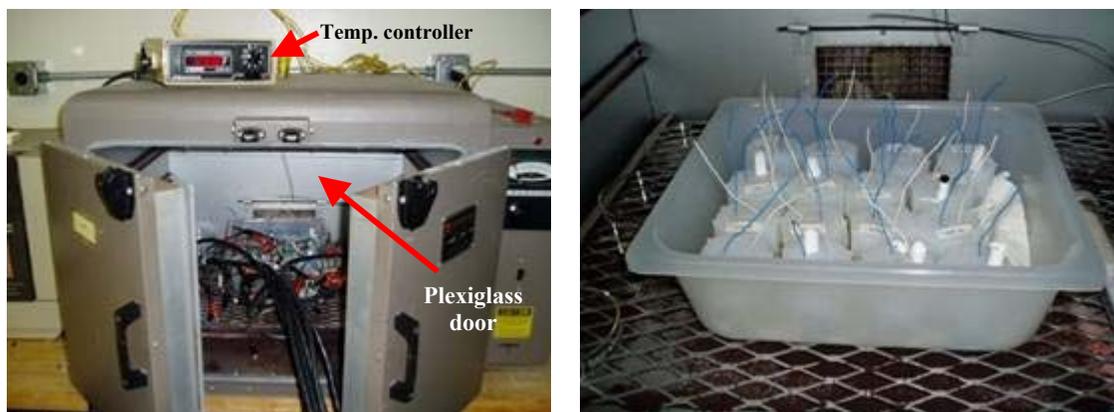
Oven during testing

Test cells in oven

Figure 3. Photograph of test setup used in electrochemical tests.

The test setup is shown in Figure 3.

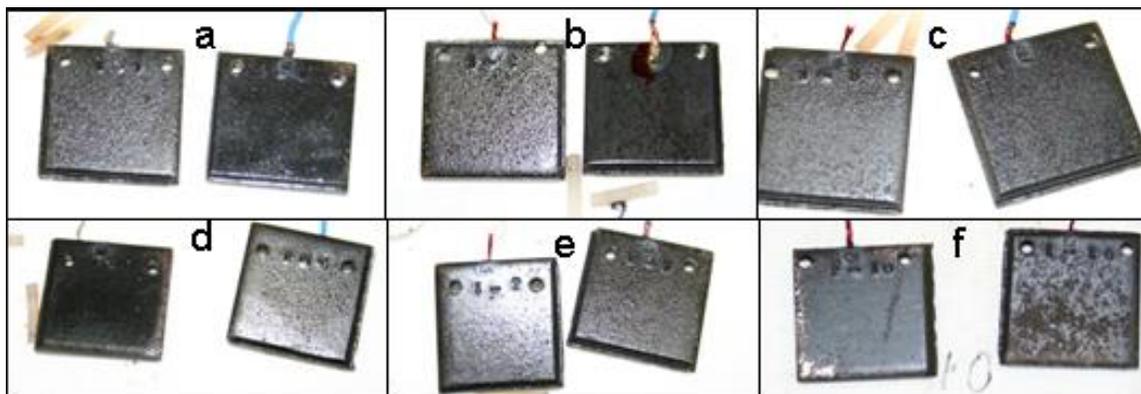
Figure 4. Photographs of carbon steel specimens exposed to ULSD and soy-based biodiesel blends with and without the presence of water: (a) 100% biodiesel, no water added; (b) 50% biodiesel + 50% ULSD, no water added; (c) 100% petroleum diesel, no water added; (d) 100% biodiesel, 1 vol% water added; (e) 50% biodiesel + 50% ULSD, 1 vol% water added and (f) 100% ULSD, 1 vol% water added. Exposure time: 2 months.

The impedance spectra indicated that the conductivity of the fuel blends was so low that no corrosion rate could be measured. Even after 90 days of testing, no corrosion rate was measured in any of the blends. Upon visual inspection of the test coupons, a small amount of surface rusting was observed as shown in Figures 4 and 5. The surface rusting was caused by a reaction between the surface oxide/tarnish layer of the steel and the fuel blend which was not detectable using EIS.

In most cases, the amount of surface rusting was slightly higher in 100% ULSD than in soy-based biodiesel or soy-based biodiesel + ULSD blends. The extent of surface rusting was also slightly higher in the case of the animal-based biodiesel and blends when compared to the soy-based biodiesel and its blends. No difference in the amount of surface rusting was seen with and without the addition of water and between ULSD and 4000-ppm sulfur petroleum diesel. The surface rusting was caused by a reaction between the surface oxide/tarnish layer of the metal and the fuel blend. The surface rust formed even on polished specimens, although to a lesser extent, as shown in Figure 6.

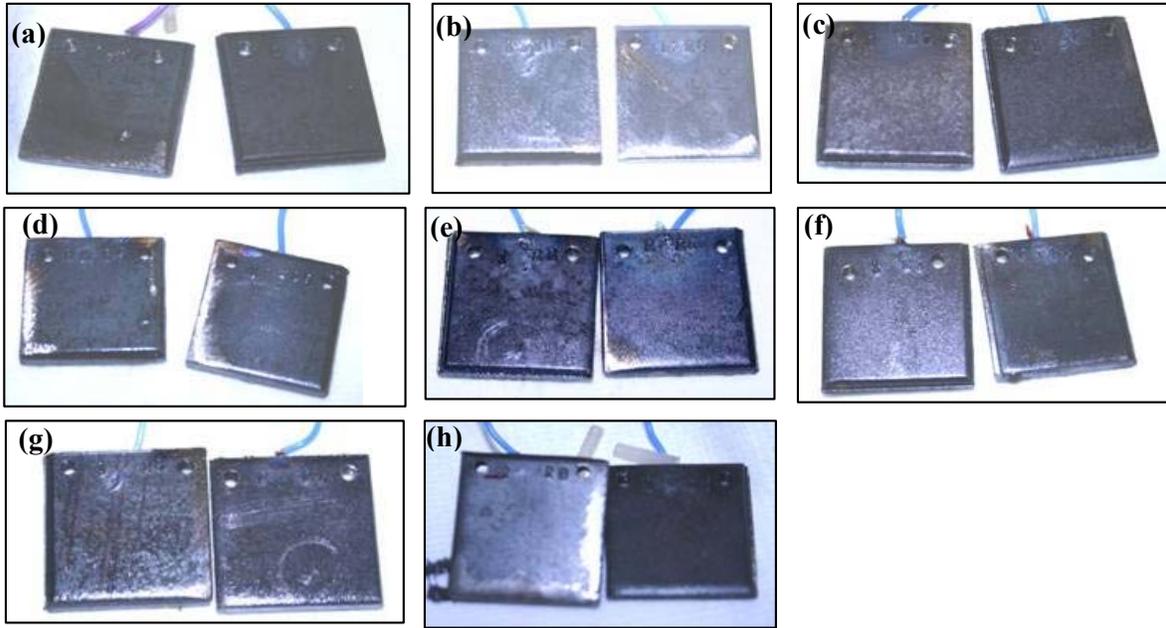
Figure 5. Photographs of carbon steel specimens exposed to ULSD or 4000 ppm S petroleum diesel and animal-based biodiesel blends with and without the presence of water: (a) 100% biodiesel, no water added; (b) 50% biodiesel + 50%ULSD, no water added; (c) 20% biodiesel + 80% 4000 ppm S petroleum diesel, no water added; (d) 100% 4000 ppm S petroleum diesel, no water added; (e) 100% biodiesel, 1 vol% water added; (f) 50% biodiesel + 50% ULSD, 1 vol% water added; (g) 20% biodiesel + 80% 4000 ppm S petroleum diesel, 1 vol% water added; (h) 100% 4000 ppm S petroleum diesel, 1 vol% water added. Exposure time: 3 months.

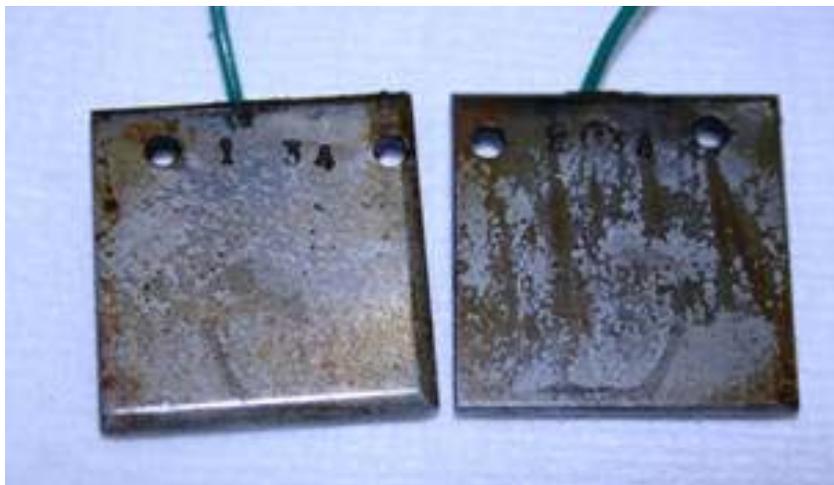
Figure 6. Photographs of carbon steel specimens polished to 600 grit, then exposed to 20% animal-based biodiesel + 80% 4000 ppm S petroleum diesel blend with the presence of 1 vol% water for 3 months.

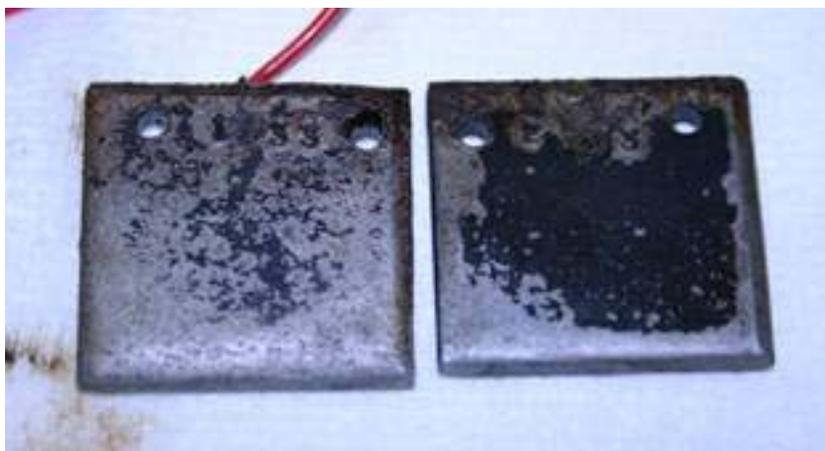
Figure 7. Photographs of carbon steel specimens exposed to aggressive fuel blend (A1 UL test fuel mixture) for 3 months.

The aggressive fuel blend caused somewhat more corrosion on the surface (Figure 7), as expected. However, the conductivity of the fuel blend (STI-33) was not high enough to measure this corrosion rate using electrochemical impedance spectroscopy. Upon examining the surface of the steel coupons exposed to the aggressive fuel blend, it was noted that the corrosion only affected the surface and it appeared to be uniform, no deep localized corrosion sites (pits) were observed.

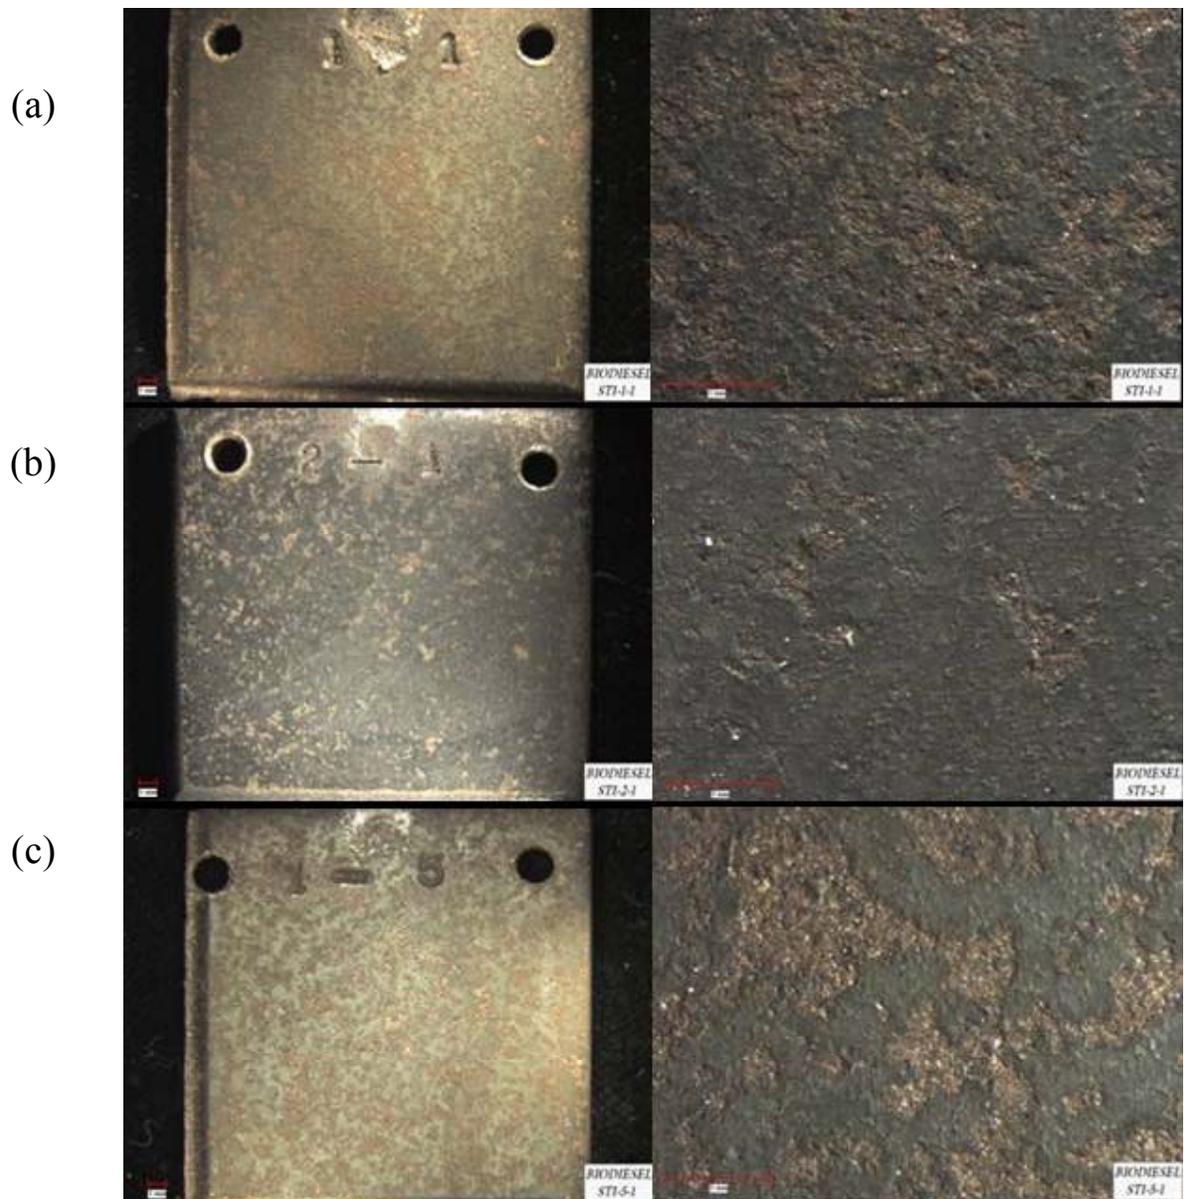
Figure 8. Low magnification optical microscope images of carbon steel test coupons exposed to fuel blends: (a) 100% soy-based biodiesel, no water added; (b) 50% biodiesel + 50% ULSD, no water added; (c) 100% ULSD, no water added.

To further investigate the surface damage observed on the test coupons, low magnification optical micrographs were taken. Representative micrographs for each set of exposures are shown in Figures 8 and 9, respectively.

The micrographs confirm the visual observations, that is, only a small amount of surface damage is present on the test coupons; no extensive general corrosion damage or pitting was observed. The aggressive fuel blend caused the most extensive pitting damage on the surface, as expected. Even these pits, however, were very shallow; the deepest pit found on the surface was approximately 13 μm deep as indicated by the depth profile shown in Figure 10. All other surface damage found on the specimens was under 5 μm deep.

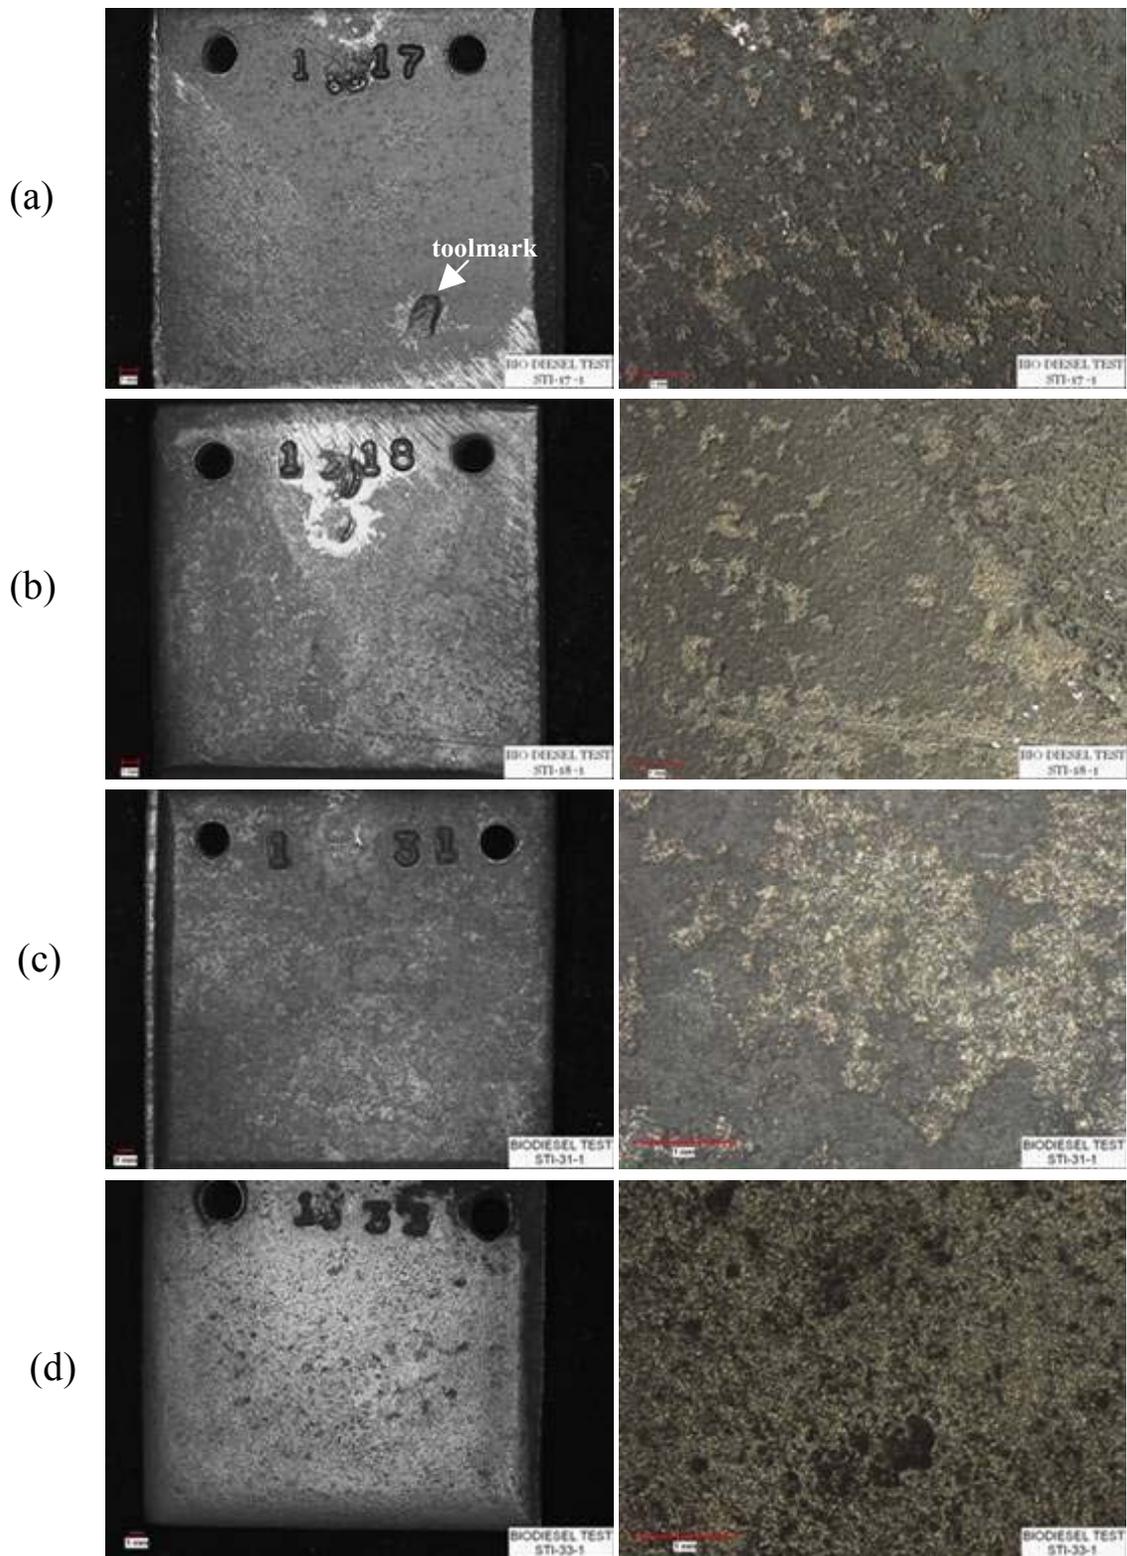
Figure 9. Low magnification optical microscope images of carbon steel test coupons exposed to fuel blends: (a) 100% animal-based biodiesel, no water added; (b) 50% animal-based biodiesel + 50% ULSD, no water added; (c) 5% animal-based biodiesel + 95% 4000 ppm S petroleum diesel, 1 vol% water added; (d) aggressive fuel blend (A1 UL test fuel mixture).

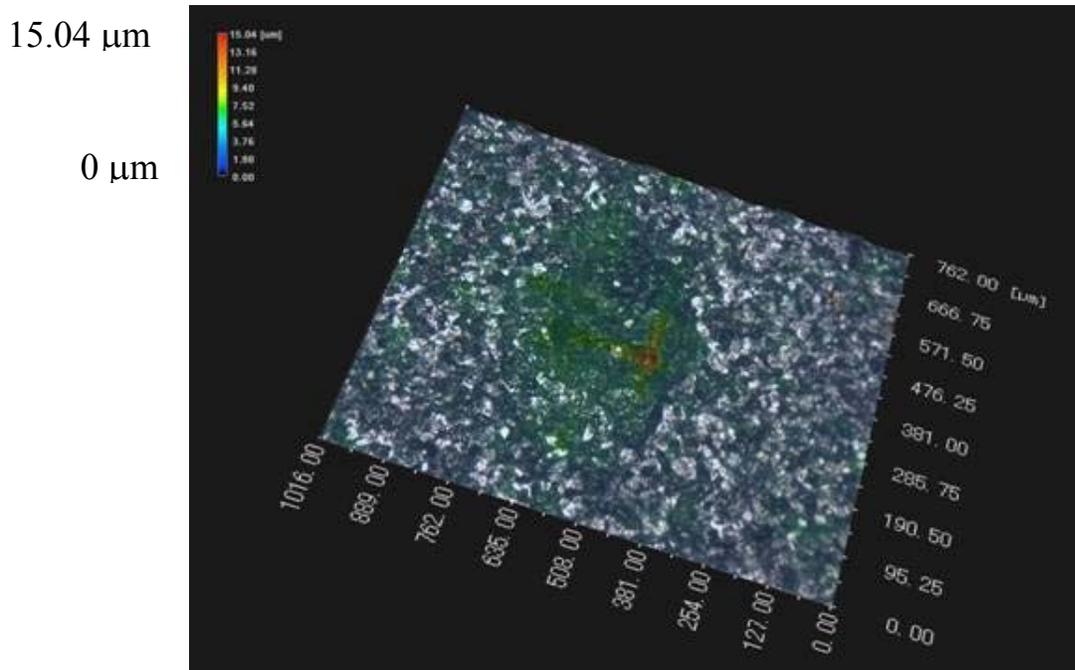
Figure 10. Depth profile of surface of steel specimen exposed to aggressive fuel blend for 3 months. The image was taken by a digital microscope.

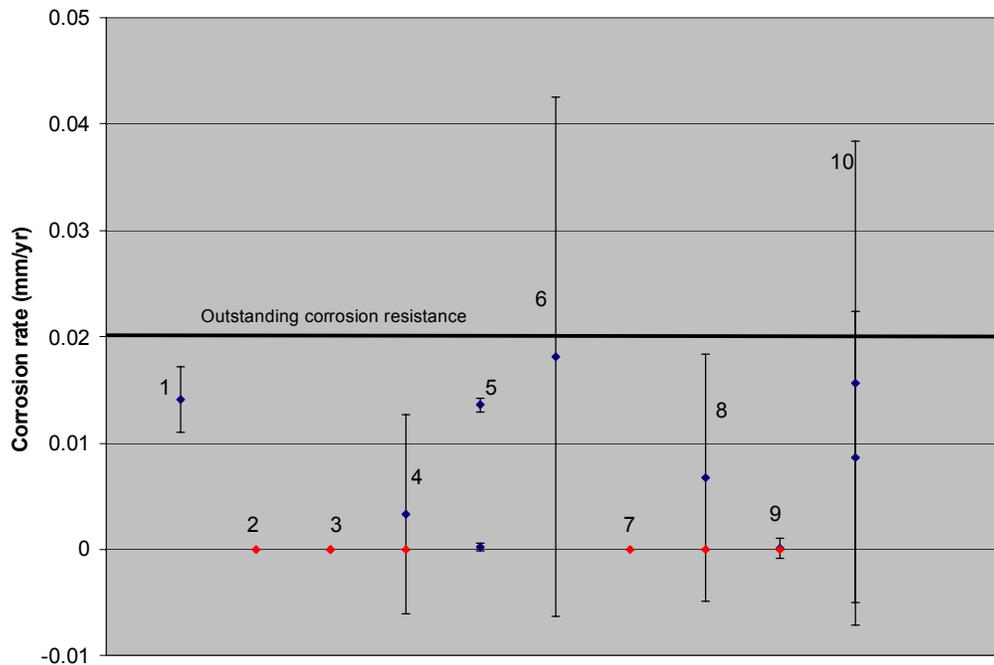
Figure 11. Corrosion rates calculated from mass changes of steel test coupons as a function of solution chemistry (set 1): (1) 100% soy-based biodiesel, no water added; (2) 50% biodiesel + 50% ULSD, no water added; (3) 20% biodiesel + 80% ULSD, no water added; (4) 5% biodiesel + 95% ULSD, no water added; (5) 100% ULSD, no water added; (6) 100% biodiesel + 1 vol% water; (7) 50% biodiesel + 50% ULSD + 1 vol% water; (8) 20% biodiesel + 80% ULSD + 1 vol% water; (9) 5% biodiesel + 95% ULSD + 1 vol% water; (10) 100% ULSD + 1 vol% water.

The calculated corrosion rates for each set are shown in Figures 11 and 12, respectively. The corrosion rates were assumed to be zero if mass gain was observed on the test coupons (red datapoints).

The corrosion rates were not significant in the case of the first set of exposures indicating the lack of corrosion in the system. The average corrosion rates were below 0.02 mm/yr, which corresponded to outstanding relative corrosion resistance for typical ferrous and nickel alloys¹. No apparent correlation was found between the corrosion rate and solution chemistry (Figure 11).

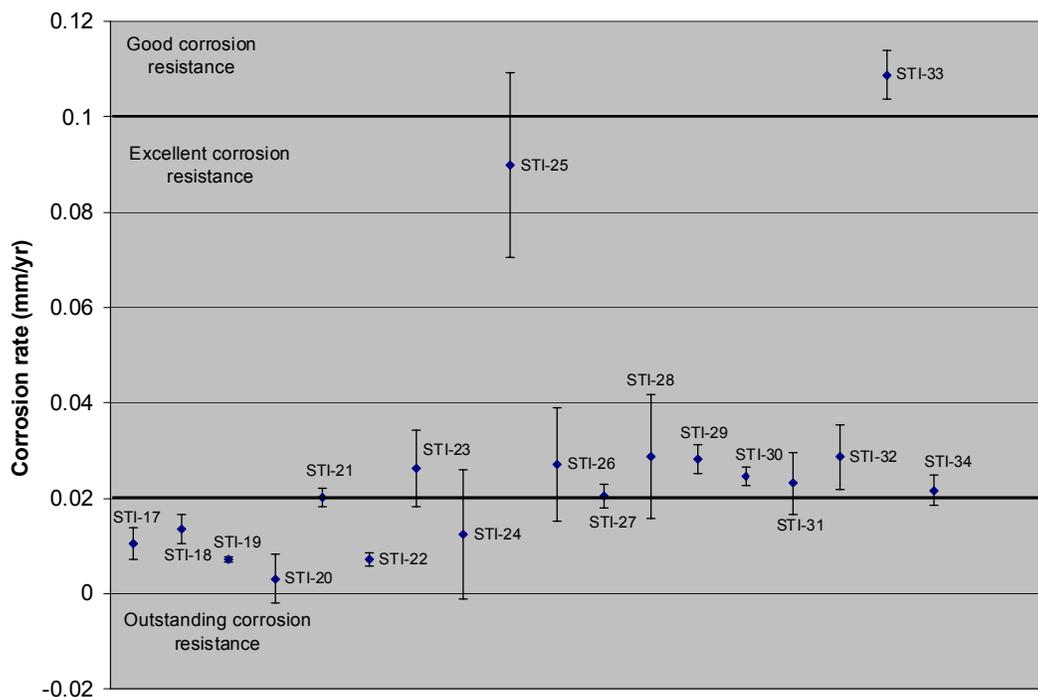
Figure 12. Corrosion rates calculated from mass changes of steel test coupons as a function of solution chemistry (set 2). The data labels correspond to the solution IDs in Table 2.

In the case of the second set of exposures, mass loss was observed in all cases; thus, corrosion rates were calculated for all fuel blends. Most of the average corrosion rate values were below 0.04 mm/yr, indicating outstanding or excellent corrosion resistance. The corrosion rates were slightly higher in a blend containing 5% animal-based biodiesel, 95% ULSD fuel blend with the presence of 1 vol% water. No trends were found between the corrosion rates and solution chemistry, similarly to set 1. Surface polishing was found to have no effect on the corrosion rate of steel (STI-30 and STI-34). The corrosion rate observed in the aggressive fuel blend was the highest of all tested solutions, as expected; although even this corrosion rate was small (< 0.12 mm/yr) and it corresponded to good corrosion resistance on the relative corrosion resistance scale¹.

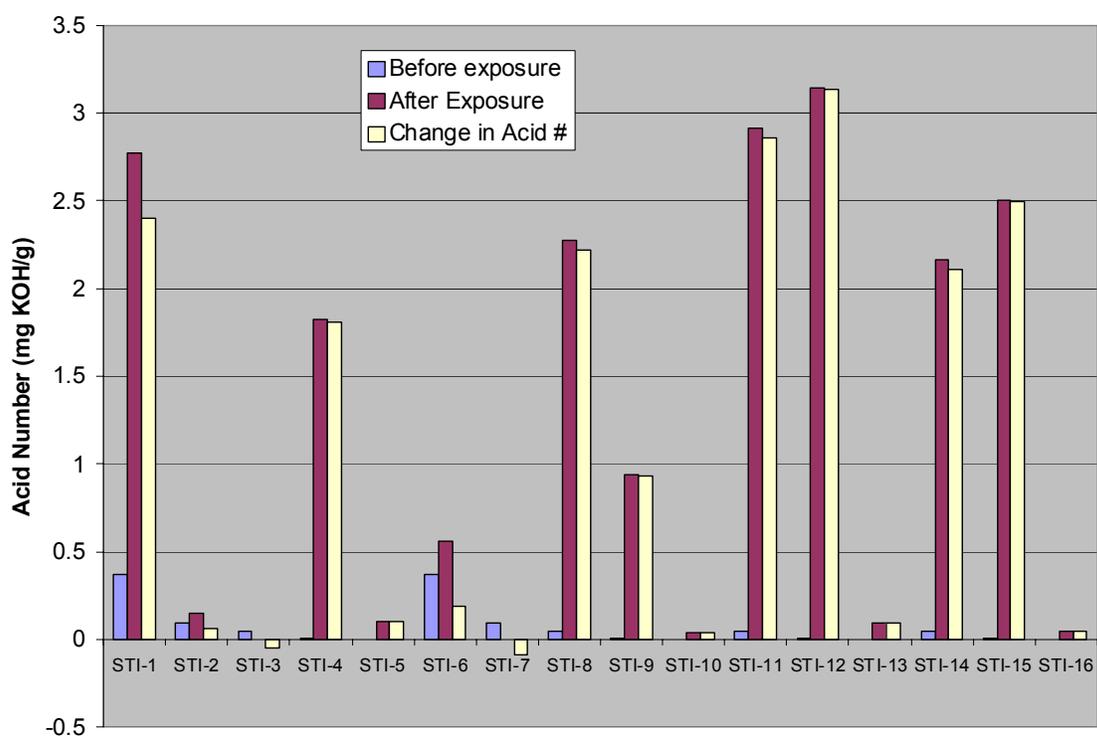
Figure 13. Acid numbers measured in fuel blends containing soy-based biodiesel before and after 90-day exposure to 46°C, as well as change in acid number.

The measured values and the changes in acid numbers are shown in Figures 13 and 14.

The measured acid number values varied between 0 and 3.2, with no apparent correlation between acid number and fuel composition. Upon exposure, the acid number generally increased slightly, although in some instances it decreased. The change in acid number was correlated with the corrosion rate determined from mass loss using correlation factor. The correlation factor between the change in acid number and corrosion rate was found to be -0.256 and -0.382 for the soy- and animal based biodiesels, respectively, indicating no strong correlation between change in acid number and corrosion rate.

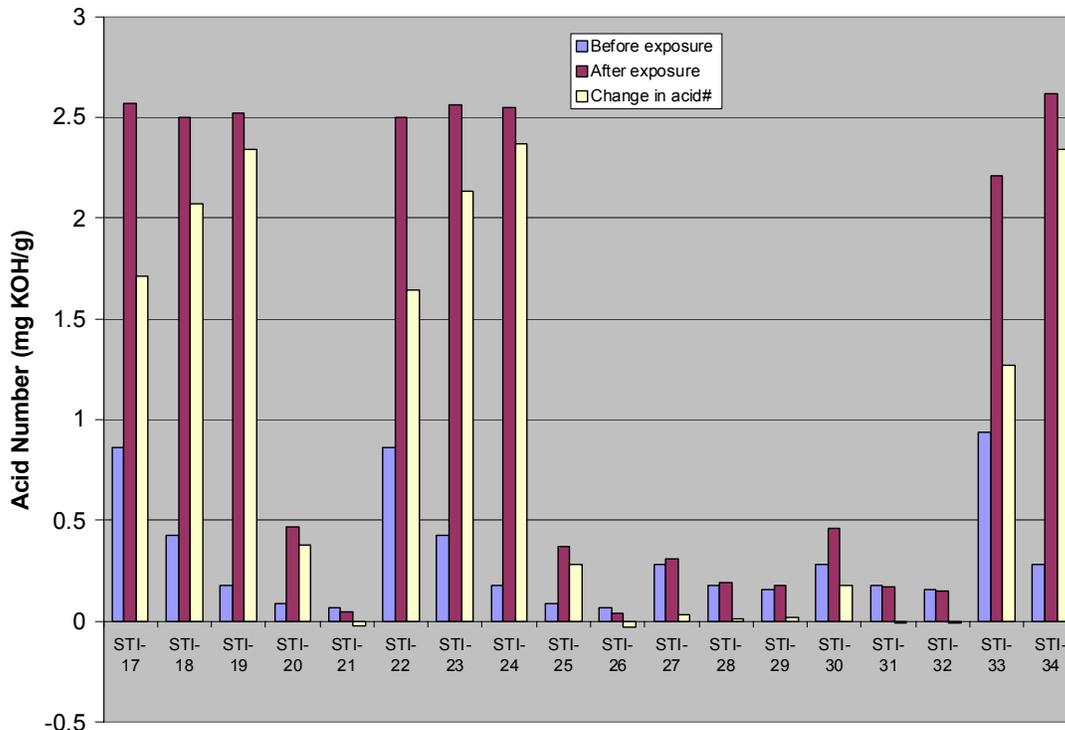
Figure 14. Acid numbers measured in fuel blends containing animal-based biodiesel before and after 90-day exposure to 46°C, as well as change in acid number.
